# **CONDITION ASSESSMENT AND RECOMMENDATIONS**

## **Stabilization of the Shaker South Family Barn**

**South Shaker Road  
Harvard, Massachusetts**

**FINAL DRAFT  
May 15, 2004**

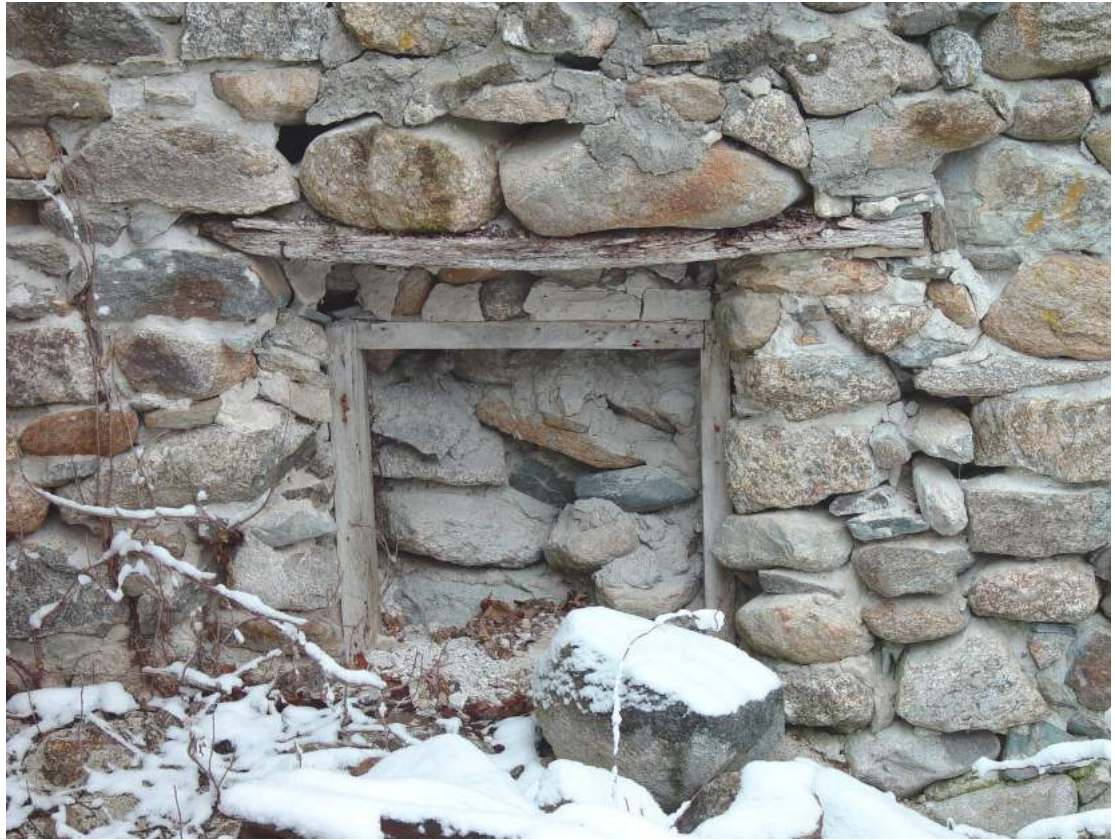
Fig. 6  
Abandoned opening at west end interior of north wall, incorporating wood lintels.

The nested pair of wood lintels framing a blind opening visible only from the interior west end of the north wall have suffered insect attack and are heavily deflected (Fig. 6). Although once commonplace in 19<sup>th</sup> century construction, the use of wood plank lintels to support inner masonry wythes is uncharacteristic of this building. In service, these normally tend to shrink, deflect, or decay after a number of years, and at some point cease to play a significant role in supporting the masonry. Vertical loads in a wall tend to distribute themselves around small openings, leaving the lintel to carry only the area of an equilateral triangle immediately above. The problem is that even a limited failure in the area immediately above these lintels could have serious repercussions on this wall, which is only in marginal condition at best.

This is the only surviving opening that carried masonry on wood lintels. These, having lost their protection from the weather, are in the early stages of failure from insect and fungal attack. The lintels should be shored via the addition of wedged timber blocking within the opening, to forestall collapse of the interior wythes above.

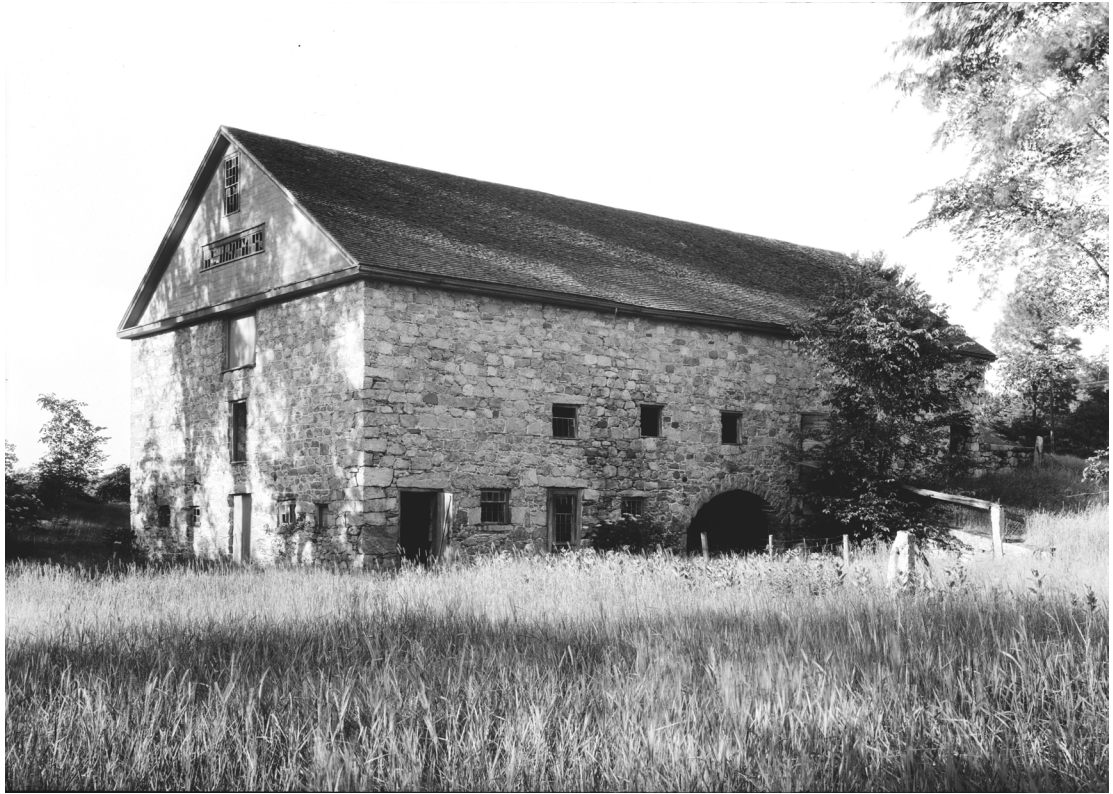
Fig. 16  
View from southwest showing beginnings of stone masonry deterioration. (HABS Photograph by Stanley P. Mixon, July 1940)

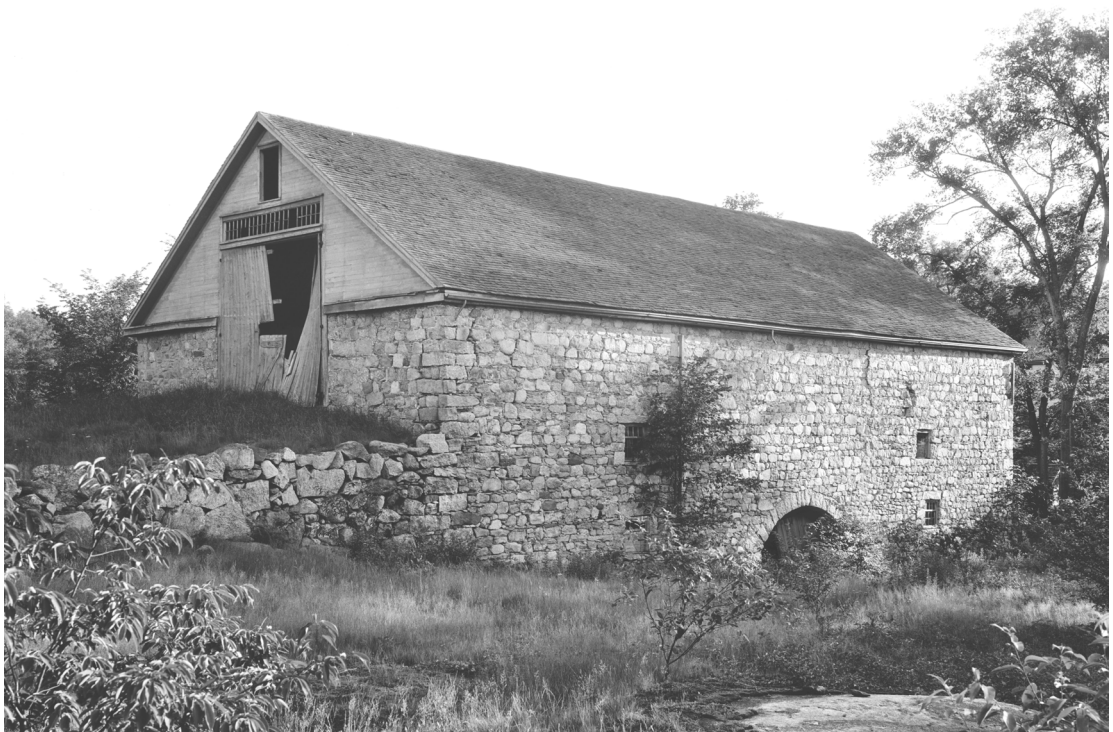
Fig. 17  
View from northeast showing developing vertical cracking systems at the northeast corner of the stone masonry. (HABS Photograph by Stanley P. Mixon, July 1940)

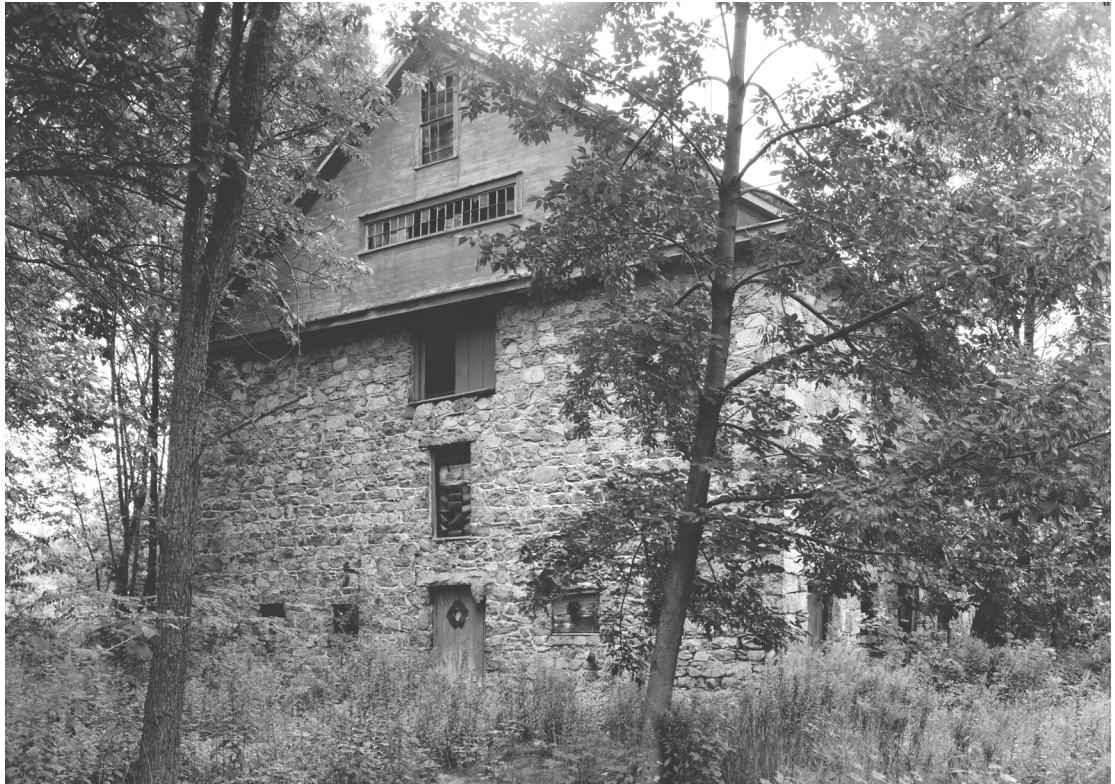
Fig. 18  
West elevation showing unchecked growth of vegetation. (HABS Photograph by Jack E. Boucher, August 1963)

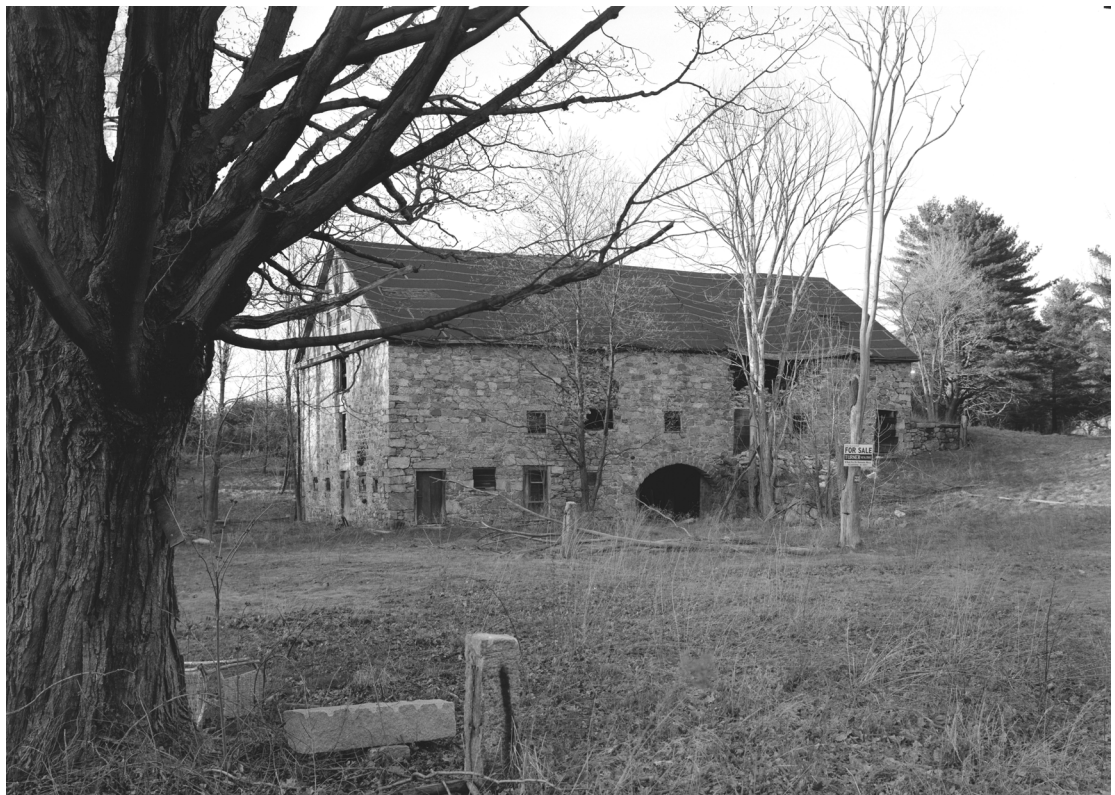
Fig. 19  
South elevation showing worsened condition of roof and stone masonry. (HABS Photograph by Jack E. Boucher, April 1963)

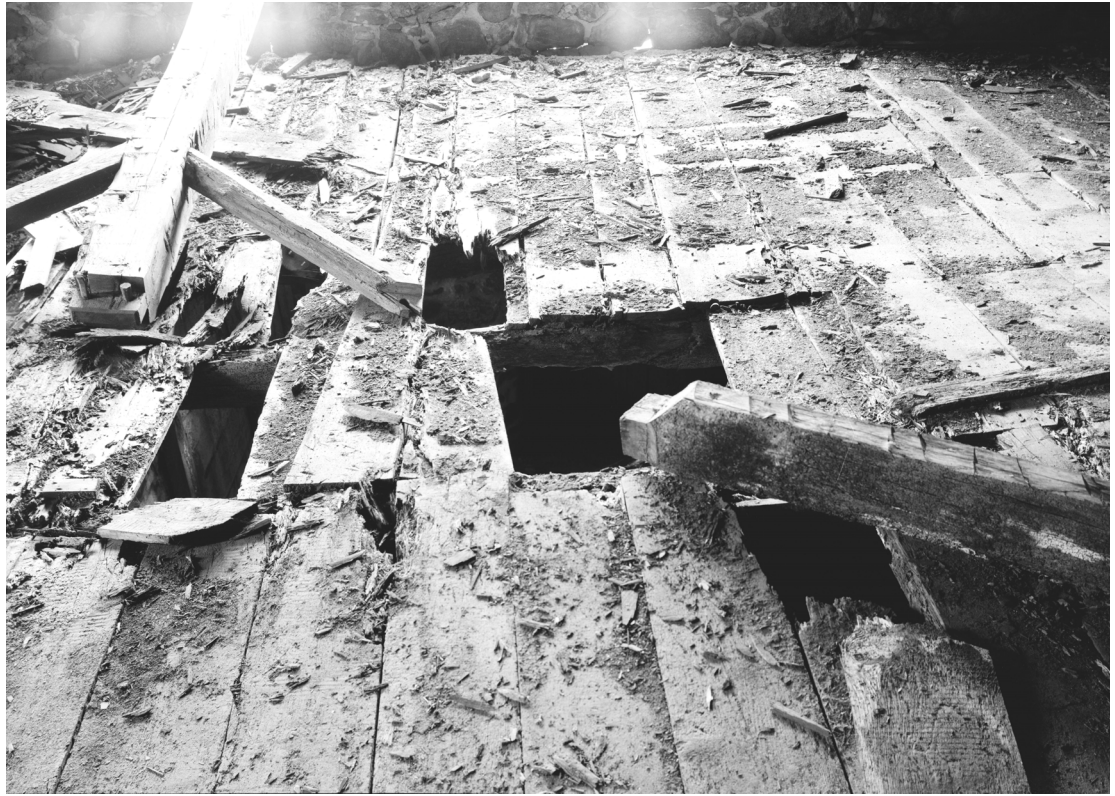
Fig. 20  
Collapse of framing and flooring perhaps attributable to poor condition of the roof membrane. (HABS Photograph by Jack E. Boucher, August 1963)

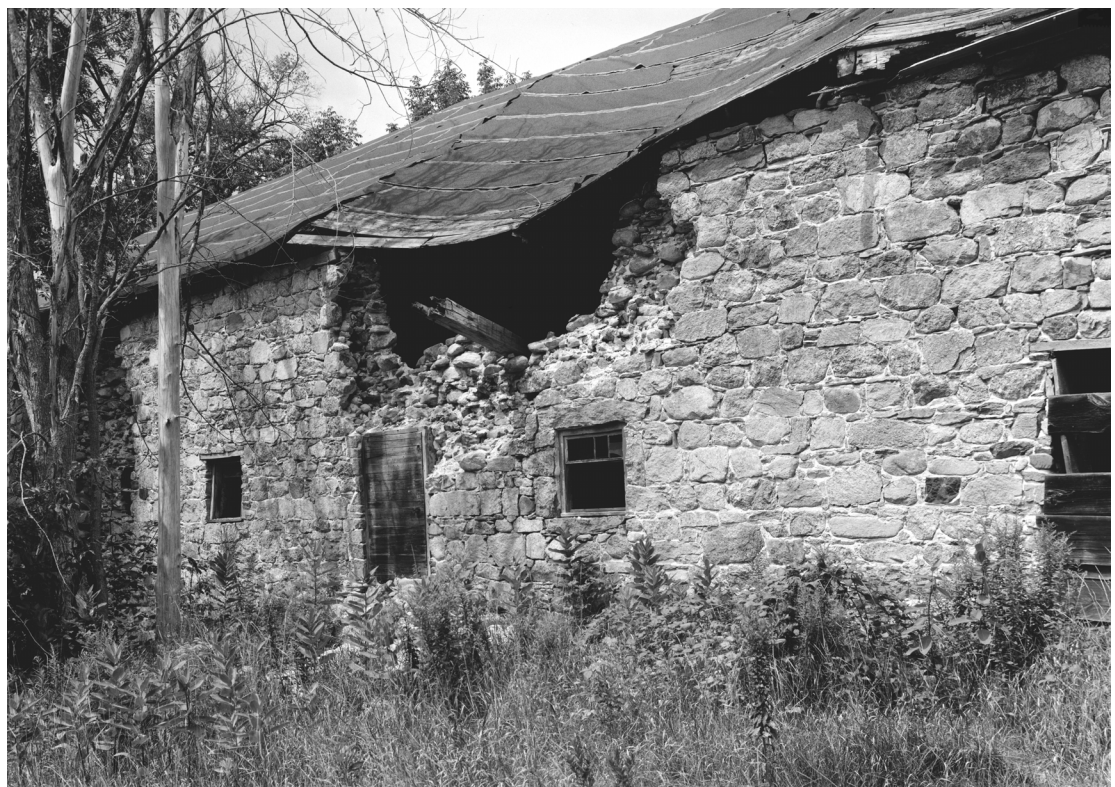
Fig. 21  
Breach in south wall stone masonry, east of arch. (HABS Photograph by Jack E. Boucher, August 1963)

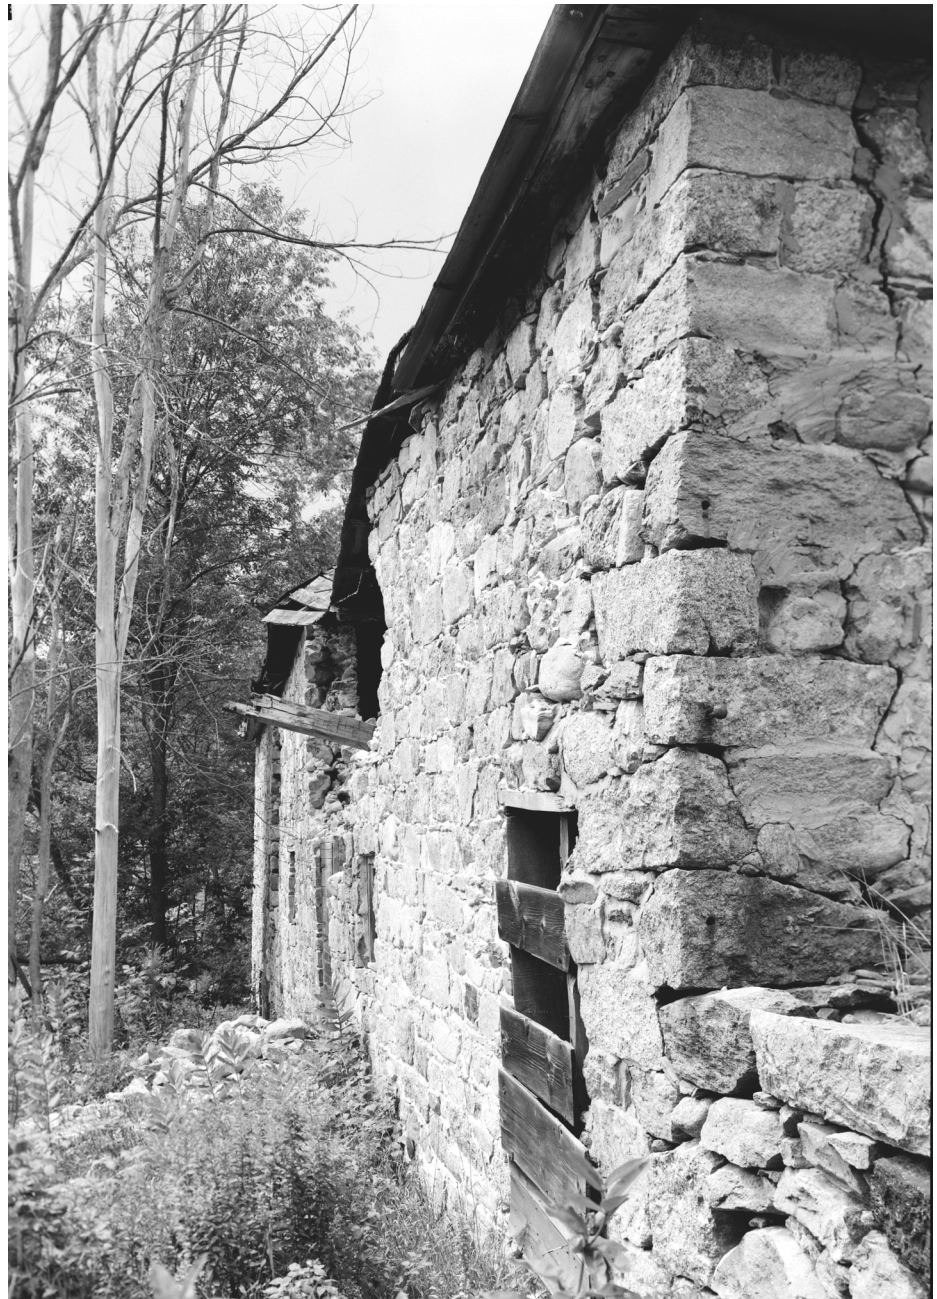
Fig. 22  
Breach in south wall stone masonry, and developing vertical cracks at  
southeast corner. (HABS Photograph by Jack E. Boucher, August 1963)

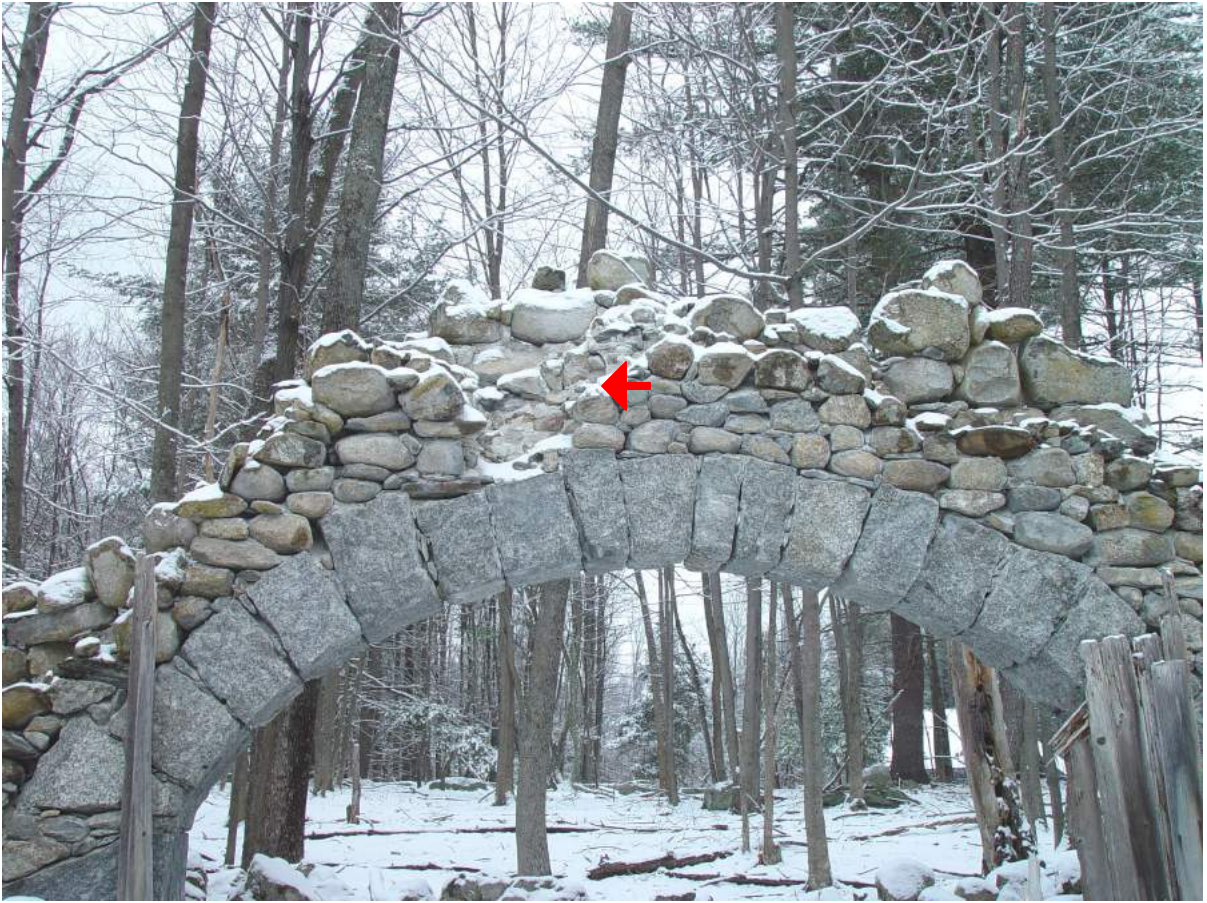
Numerous masonry features however survive in potentially unstable condition, having lost backing wythes, lateral restraint, and plumbness. Stones in some formations hang cantilevered, out of their intended geometry, or poorly keyed, and significant cracking systems have developed through major wall surfaces. Localized collapses are thought to have occurred within the past few years, and undetected falling of small numbers of stones is suspected to occur on a regular basis. One localized collapse in fact occurred above the north arch sometime between site visits on February 7 and March 9, 2004 (Fig. 23).

Fig. 23  
Recent collapse of masonry above north arch, occurring early in 2004.

Exposure of the top wall surfaces to weathering presents an even greater threat to the masonry integrity. These surfaces, previously protected by roof framing and trim, now provide unobstructed avenues of water infiltration to large numbers of mortared head joints (between respective ends of masonry units) and collar joints (between the respective wythes of the wall). Since at least 1975 these vulnerable joints have freely collected moisture from rain and snowfalls, and in the latter case are exposed for prolonged periods while snow sits unmelted (Fig. 26). The results of this exposure are readily apparent along nearly the entire perimeter of the surviving walls, and are manifested by one or the other of the wythes having been lost to mortar dissolution and frost jacking (Fig. 23).

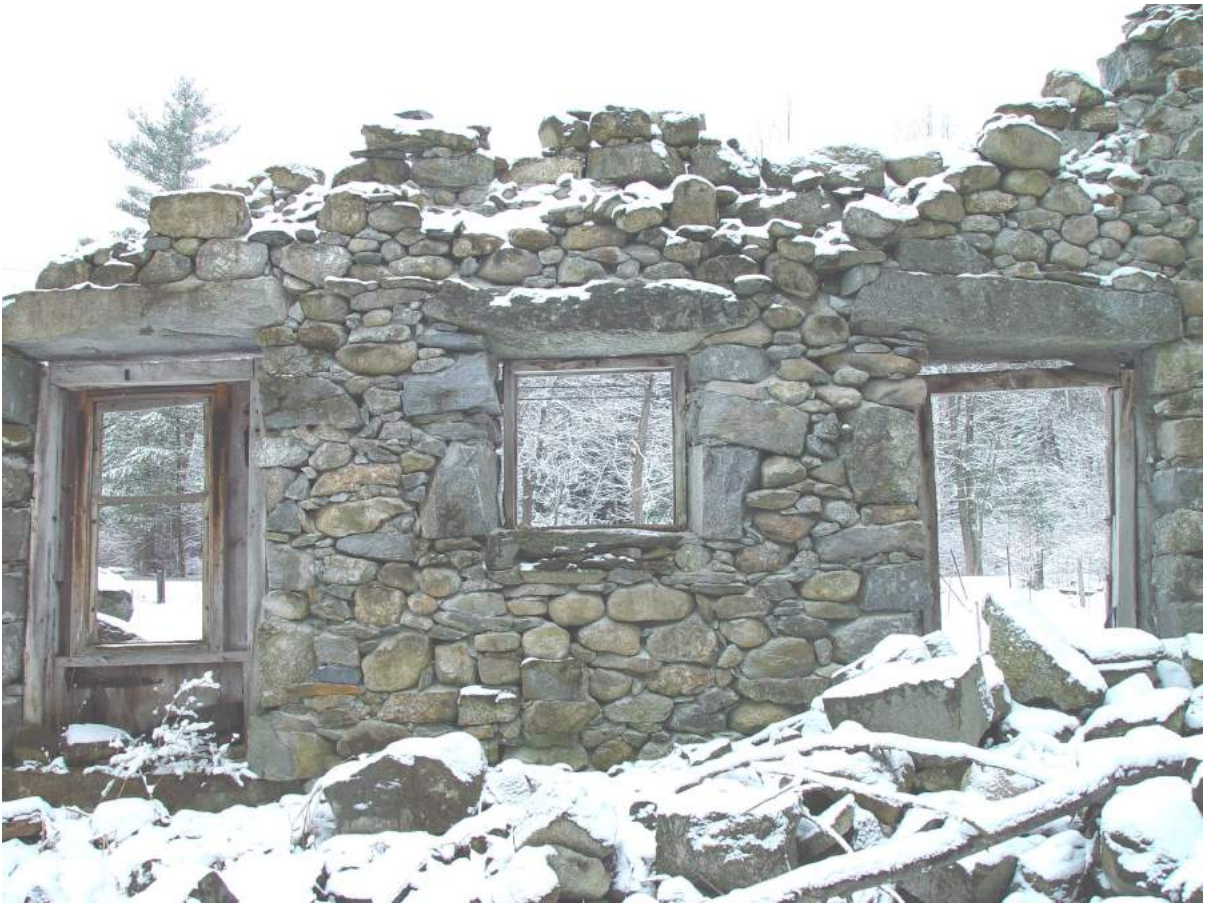
Fig. 26  
Snow sitting atop unprotected masonry head and collar joints.

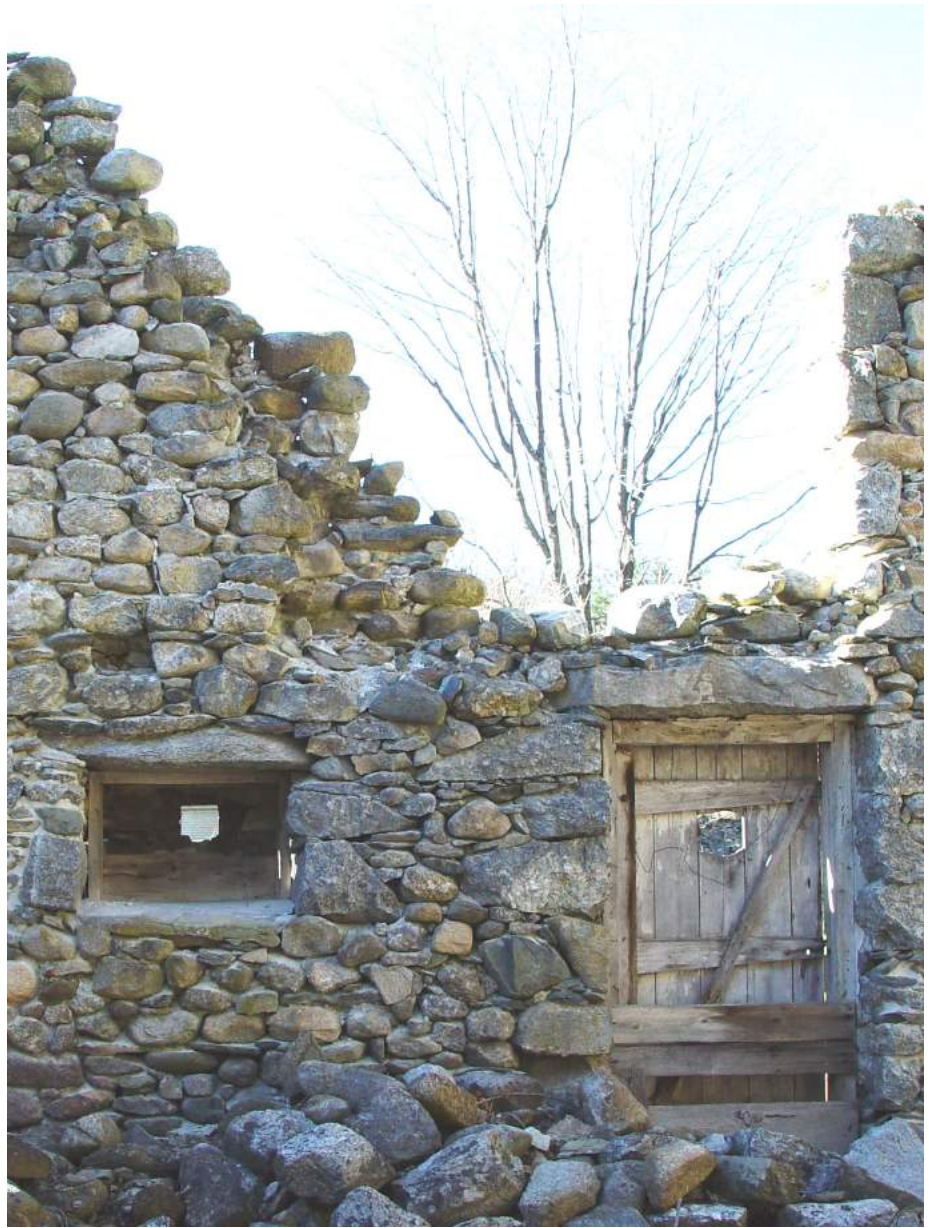
The condition is most critical where multiple courses of inner or outer wythes are missing. This occurs along the west wall adjacent to the 2<sup>nd</sup> story opening (Fig. 27), at the northwest and southwest corners, above the apex of the south arch, and along the east and west lower reaches of the north arch. Although both wythes survive above the apex of the north arch, separation is progressing such that the wythes are leaning in opposite directions.

Fig. 27  
Substantial loss of interior wythe between west wall window and door  
lintels.

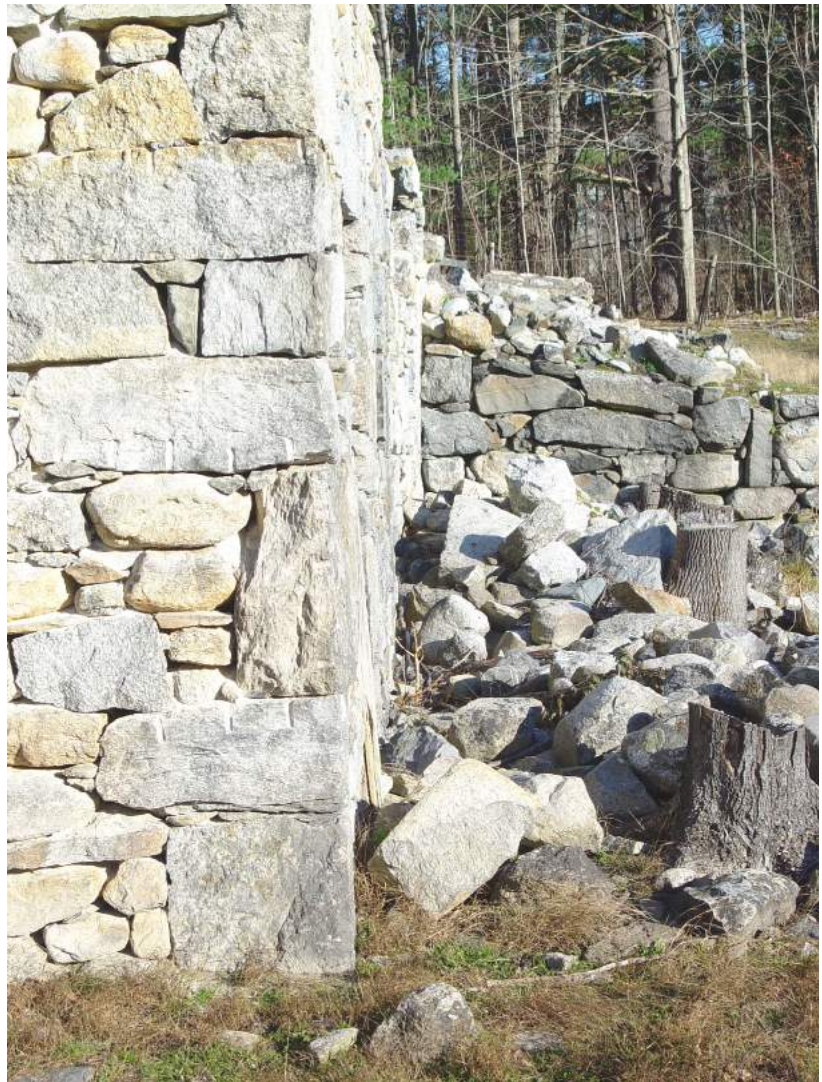
Original natural lime mortar survives in numerous locations on the building but is heavily weathered. In areas subjected to constant rainwater washing and percolation, disaggregation (or loss of binder) has occurred (Fig. 28). While the quality of the exterior wythe of stonework may serve to resist gravitational loads without assistance of mortar bond, the lesser quality of the interior wythe in many areas creates a greater mortar dependence. Extensive repointing of weathered joint work will ultimately be necessary, but relatively fewer areas are in critical condition at present.

Fig. 28  
Heavily weathered mortar  
joints at southwest corner.

- h) Repoint interior southwest corner masonry (south and west walls).* \$7,200  
 Rake all interior southwest corner masonry, top to bottom, within reach of staging sections. Repoint with natural lime mortar, reinstalling galleting where missing.

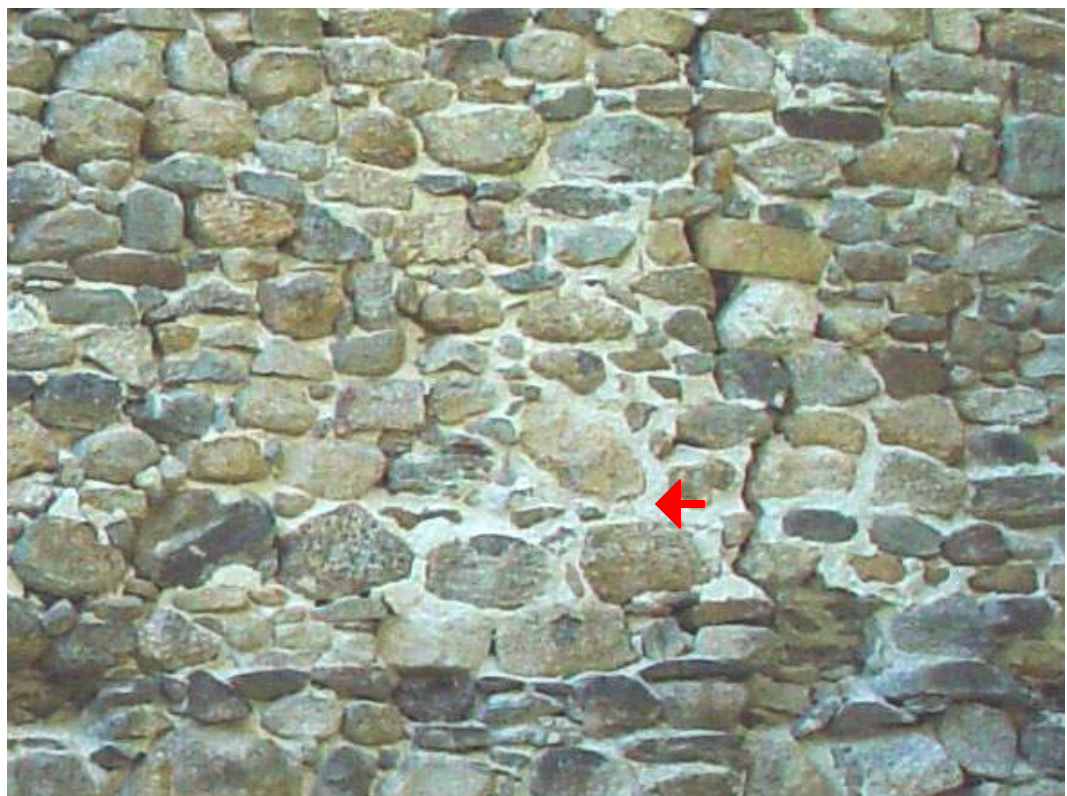
Several instances of prior inappropriate repairs of weathered joints are also in evidence. In these, Portland cement-based mortars were used to perform repointings. Although higher in strength and less prone to weathering, Portland cement mortars are visually incompatible with the historical materials (Fig. 29). Worse, their properties in this application may tend to encourage water entrapment in the walls. This is primarily due to their lacking the permeability of natural lime mortars, a characteristic that is important in allowing the wall to dry once infiltration has occurred. Also, their lacking of lime mortar's autogeneity, or self-healing ability, means they cannot accommodate gradual shifts and settlements without cracking and forming avenues of water entry. Fortunately, the extent of this usage does not appear to be great, and can be easily rectified.

Fig. 29  
Pointing repairs executed  
with incompatible Portland  
cement mortar.

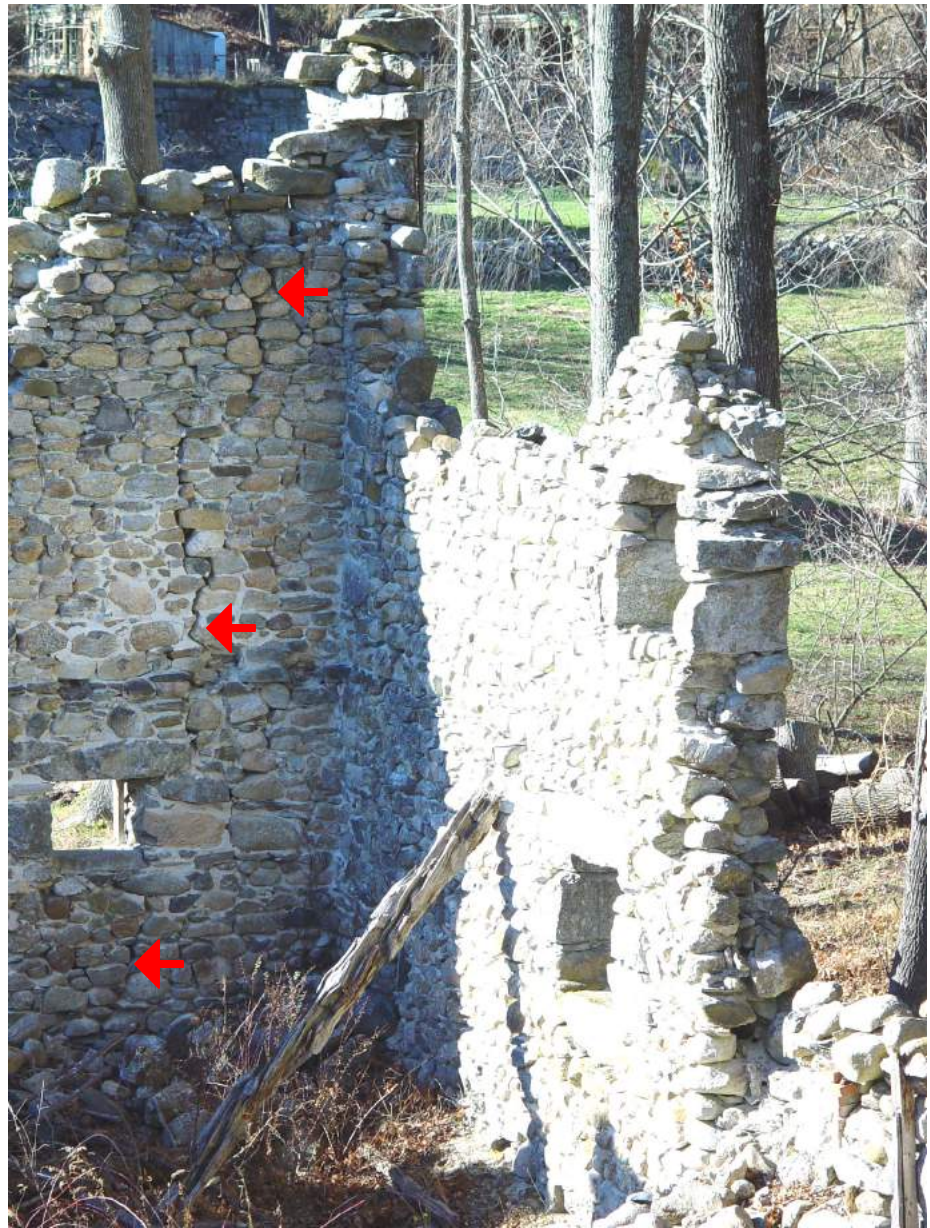
Several vertical cracking systems are apparent in the west wall, particularly from the exterior. At least one of these (near the northerly corner) is readily identifiable on both interior and exterior, and may require shoring to prevent loss of that corner and the westerly reach of north wall (Fig. 30). The origins of these are unknown, however some, including the one near the one near the northerly corner, are discernable in 1940 HABS photos. This suggests that they are more likely attributable to gradual movements than to any direct stress from the collapse itself.

Fig. 30  
Major vertical cracking system developed in northwest corner.

Although the northwest corner appears highly unstable, the addition of temporary emergency shoring may arrest further development of its failure, and allow some time to address even more

To counteract the continued development of the bulge, and of the northerly lean of this end of the north wall that has been facilitated by the major vertical crack in the adjoining west wall, install shores along the 24-foot length of the surviving two-story section. Shores may be comprised of up to 5 pairs of wood poles from rot-resistant species, spaced at 6-foot intervals along the wall. Each pair would engage the wall at 1<sup>st</sup> and 2<sup>nd</sup> story window lintel heights respectively via a vertical plank in full contact with the wall and restrained at its foot. Shores should be tied horizontally and diagonally to one another, and footed against timber or masonry pads to allow wedging as a means of adjusting lateral pressure.

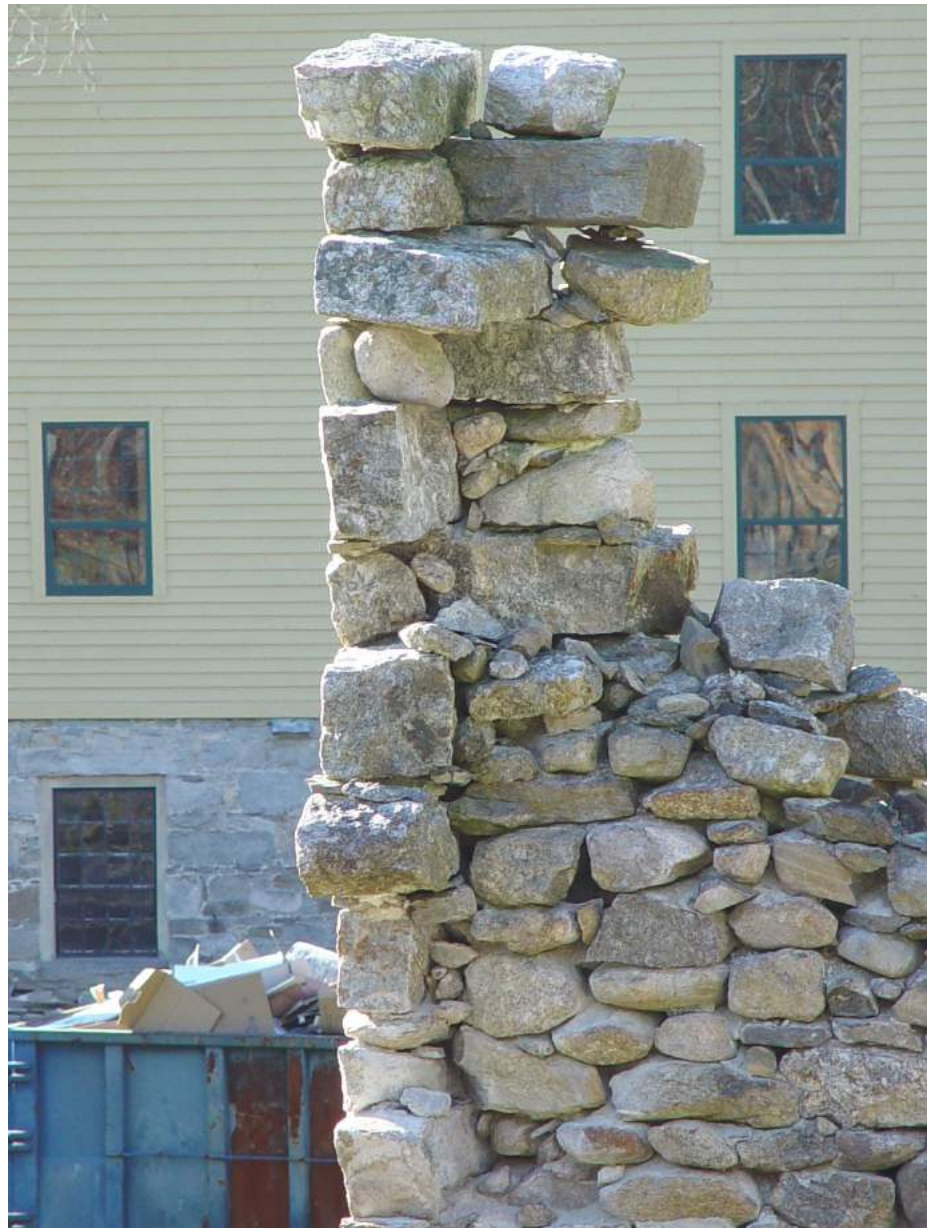
Fig. 31  
Top of southwest corner, showing loss of inner wythe.

Stability of the southwest corner is also impacted by adjacent vertical cracking systems in the west wall, and by the geometry of the surviving "chimney" which incorporates cantilevered stones and lacks a backing wythe. While this is the first feature recommended to receive serious stabilization, the masonry work should be carried out to the greatest extent possible with a temporary emergency shore in place.

Long-term stability of the southwest corner requires reinstating limited quantities of masonry on the south and west walls adjacent to eliminate cantilevers and better engage the surviving work into the wall. The work generally involves replacing missing wythes, rationalizing transitions in vertical elevation, and capping the top of the wall to protect exposed collar and head joints. Because significant expense is invoked by constructing staging to access the work, all less critical aspects of masonry preservation within reach, particularly interior and exterior pointing, should also be addressed while the staging is in place.

The chimney at this location consists of mostly facing stones. Replace the missing backing with salvaged units set in lime mortar, leaving keying opportunities for adjacent work as it in turn is reinstated. Level the wythes from outside to inside along the top, ready to receive additional infill or protective caps.

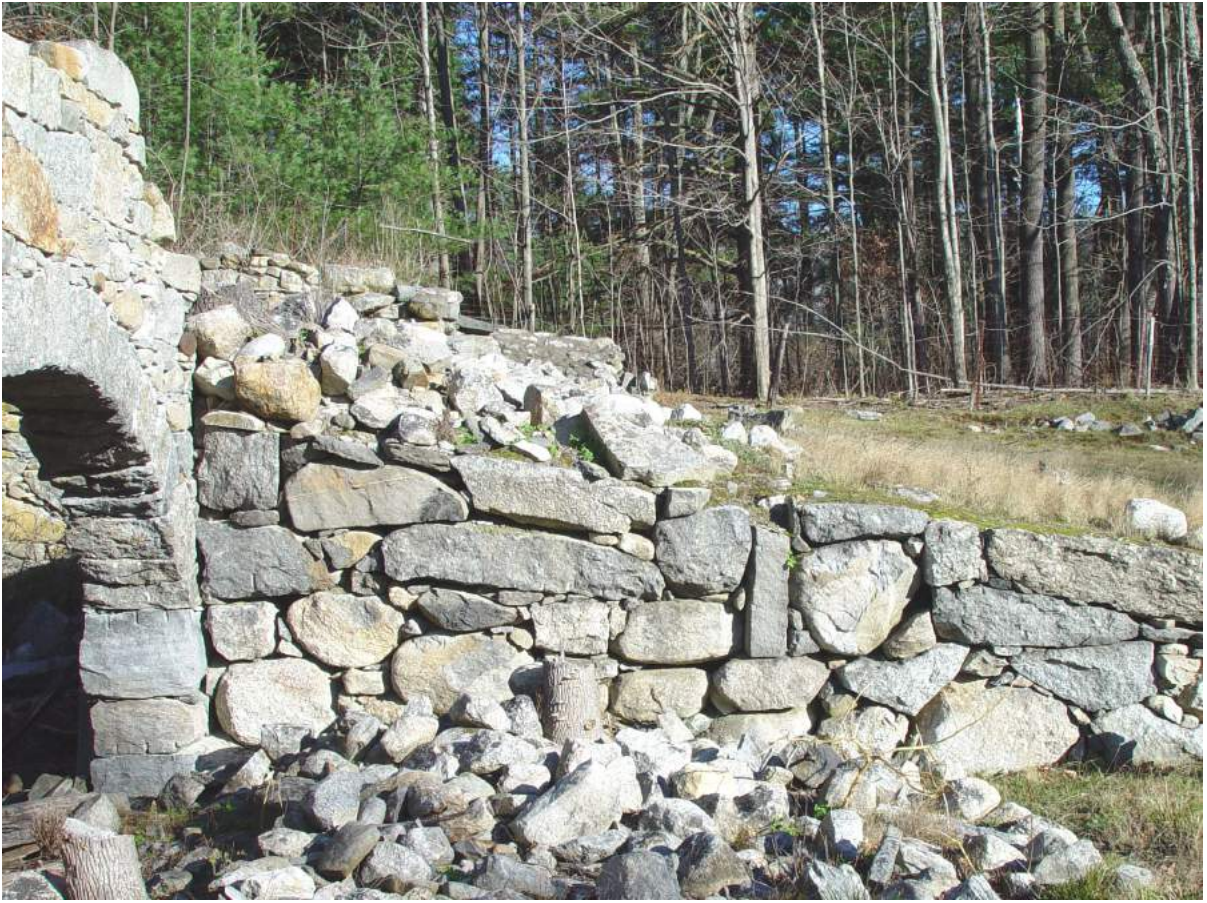
The north arch retains its geometry substantially intact, and is threatened only by deteriorating wall conditions above and at each end adjacent. The collapsing field above imparts eccentric loading. However, that problem is exceeded by the potential loss of lateral restraint at the springing points, attributable to missing wythes in wall sections adjacent. The south arch, while also eccentrically loaded by an unstable mass above, enjoys far greater lateral restraint at its springing points. Its problem is that the easterly end has wracked out of plane by lateral pressure of the earthen south ramp. Any continued movement of the semi-engaged cheek wall of this ramp might destabilize the arch (Fig. 35).

Fig. 35  
Dry-laid ramp cheek wall semi-engaged to jamb of south arch.

Semi-permanent shoring may be required at the easterly jamb of the south arch to counteract a developing inward lean caused by lateral loading from the south earthen ramp, which first engages the south wall at that point. The lean of this wall section is skewing the arch geometry, and may eventually cause collapse of the arch. The adjacent leaning semi-engaged west cheek wall of the south ramp may also require remedial shoring to prevent its adversely impacting the arch geometry. The ultimate decision to install these shores should be contingent on an analysis of the development rate of the lean. If installed, these shores should remain until such time as the retaining wall and cheek wall are reconfigured to adequately resist their lateral loads.

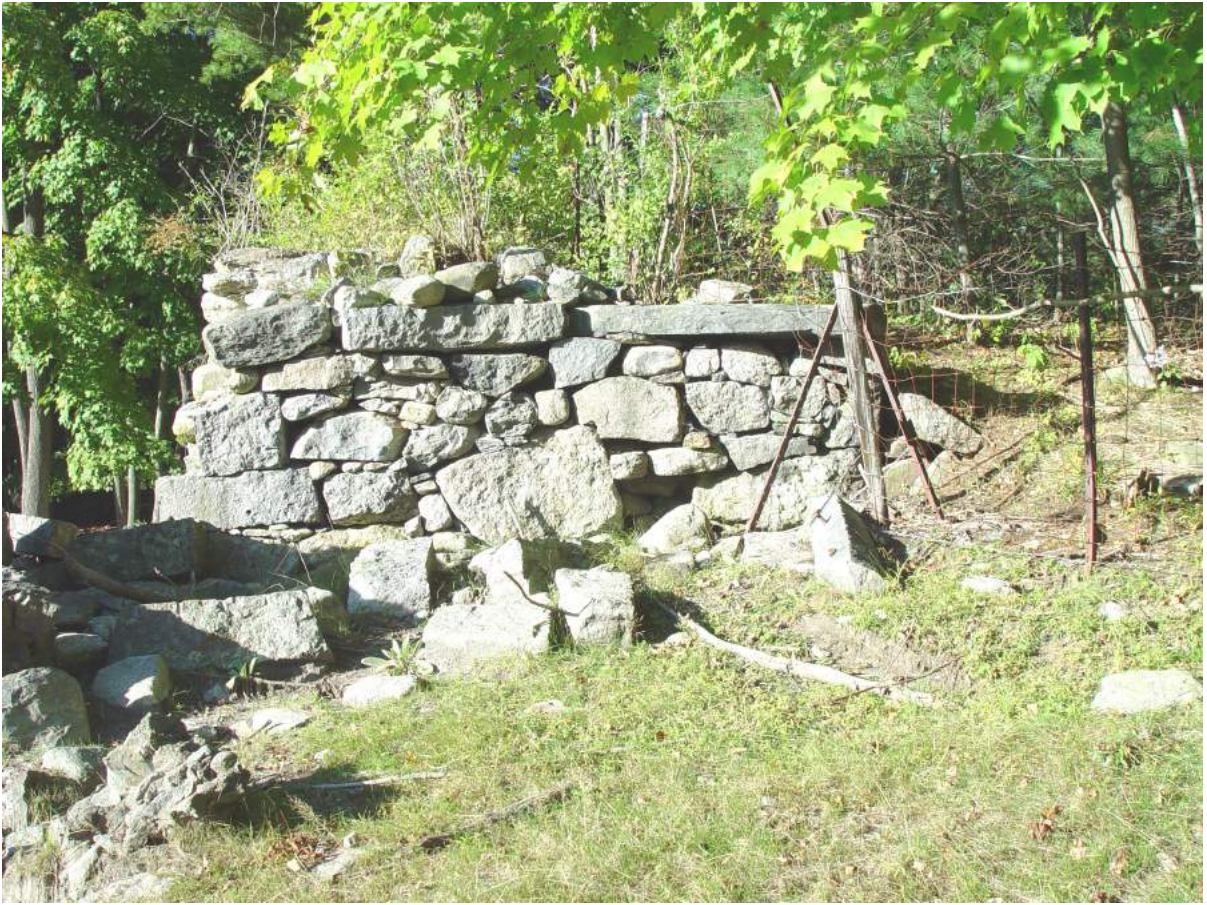
Proliferation of plant growth on and adjacent to surviving walls has accelerated their demise. Volunteer shrubs on the easterly reaches of the south wall, and along the tops of the retaining walls bounding the easterly earthen ramp retain high levels of moisture in the masonry during the growing season, and dislodge stones by the spread of their root systems (Fig. 36). Trees growing adjacent to the walls also encourage moisture retention in the adjacent masonry, and occasionally damage walls via direct impact of falling branches. Tree root systems present a larger problem in that their spread dislodges foundations directly via expansion of their respective length and girth. They may in certain circumstances also cause indirect damage via locally depleting soil moisture sufficiently to cause compaction and subsidence at the footings. Since the root systems can generally be presumed to spread to roughly the circumference of a tree's crown, any tree whose crown overhangs the structure can be construed to impart a threat to the walls via these mechanisms. Needless to say, trees in poor condition that are situated nearer to the walls than their respective heights also present a threat of impact from windfall.

Fig. 36  
Dislodging of copings on cheek wall of easterly ramp exacerbated by vegetation growth.
